Buddhist Heritage of Kurundi

Bauddhaloka Foundation

2023

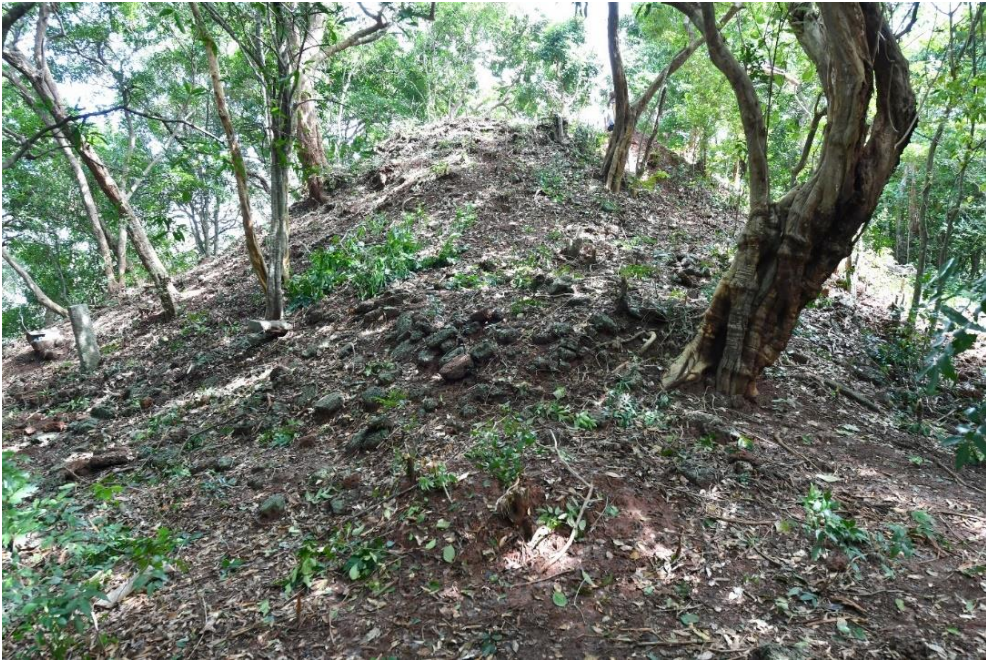
The *stūpa* before excavation

The excavation of the *stūpa* commenced on 26 January 2021. At the commencement of the excavation, the *stūpa* mound was observed to be covered with plants and bushes such as Milla, Seru, Mora, Veera and Velang. An unauthorized excavation had been performed from the top of the *stūpa* to the interior of the dome. The excavated pit had later been filled with

bricks and other materials in order to cover it (Kānīm Vyāpruti Vārtāva 2021:19).

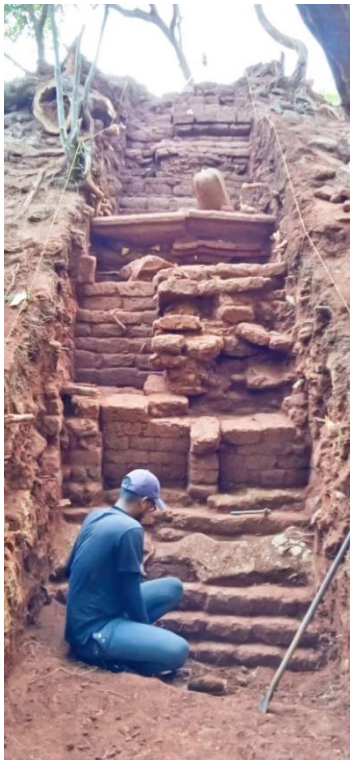
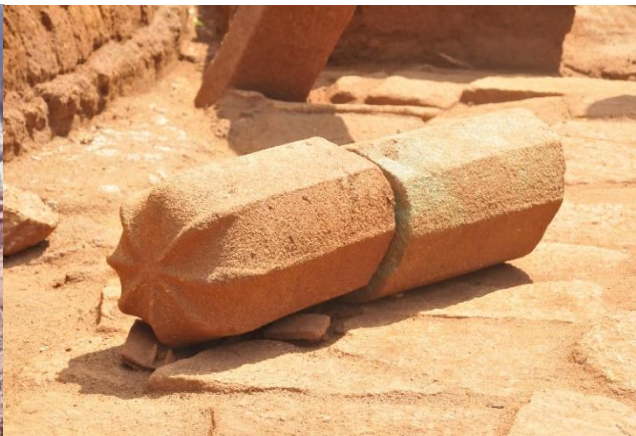
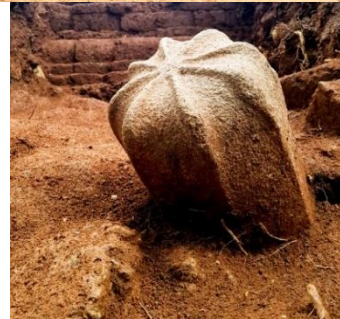
The *yūpa* stone discovered from the excavation of the *stūpa*

The *stūpa* was restored to its original form, using old *kabok* stones as well as manufactured *kabok* stones of similar specifications. According to archeological conservation methodology, the *stūpa* was conserved using a replica of the *yūpa* stone similar to that found in other *stūpas*.

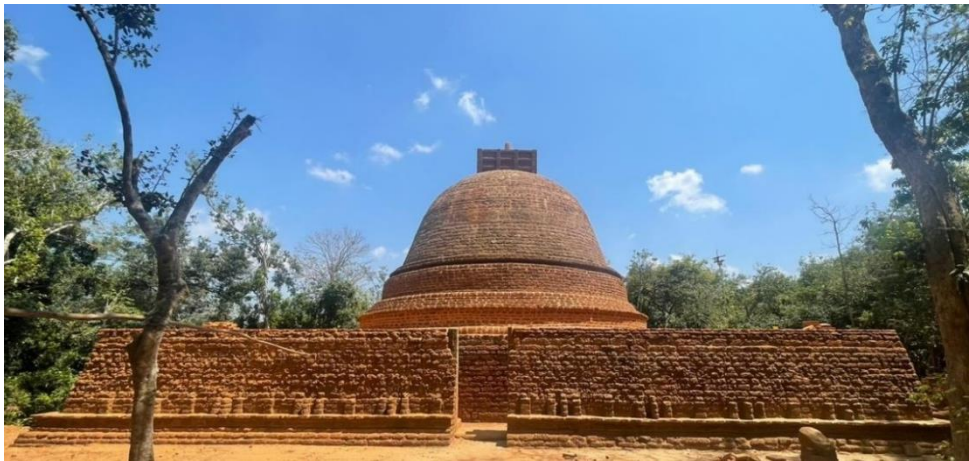
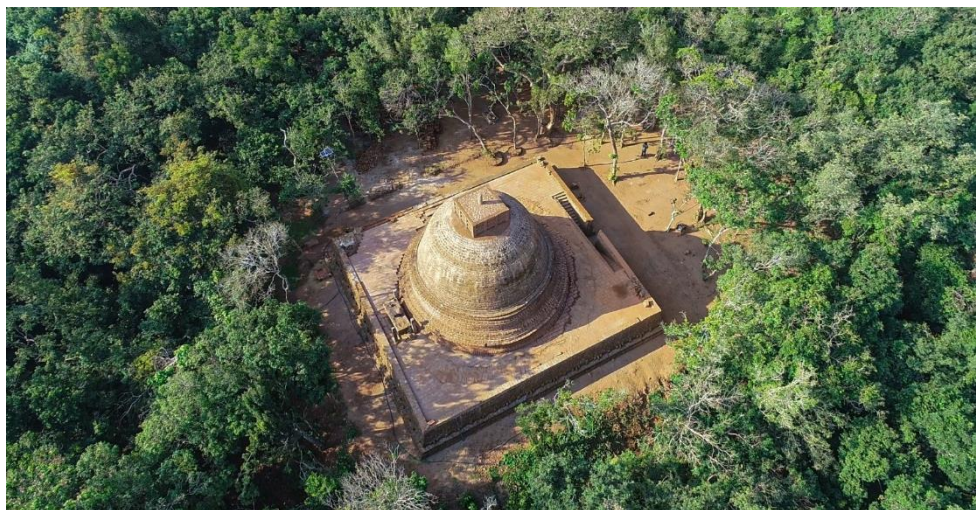
The *stūpa* after conservation

that this *stūpa* has clearly the shape of a large lotus, and that such characteristics are not found in any other *stūpa* in the country. According to him, this is the only lotus-shaped *stūpa* found in the country. Amarasinghe also mentions that the *stūpas* considered as lotus-shaped by Prof. Senarat Paranavitana do not consist of such characteristics. He further states that a *stūpa* does not become a lotus-shaped *stūpa* merely due to small-scale lotus-petal mouldings at its base. Amarasinghe assumes that the shape of the dome of this *stūpa* may have corresponded to the shape of a lotus and he surmises the *stūpa* belongs to the 7th-9th centuries according to its design style and its features.

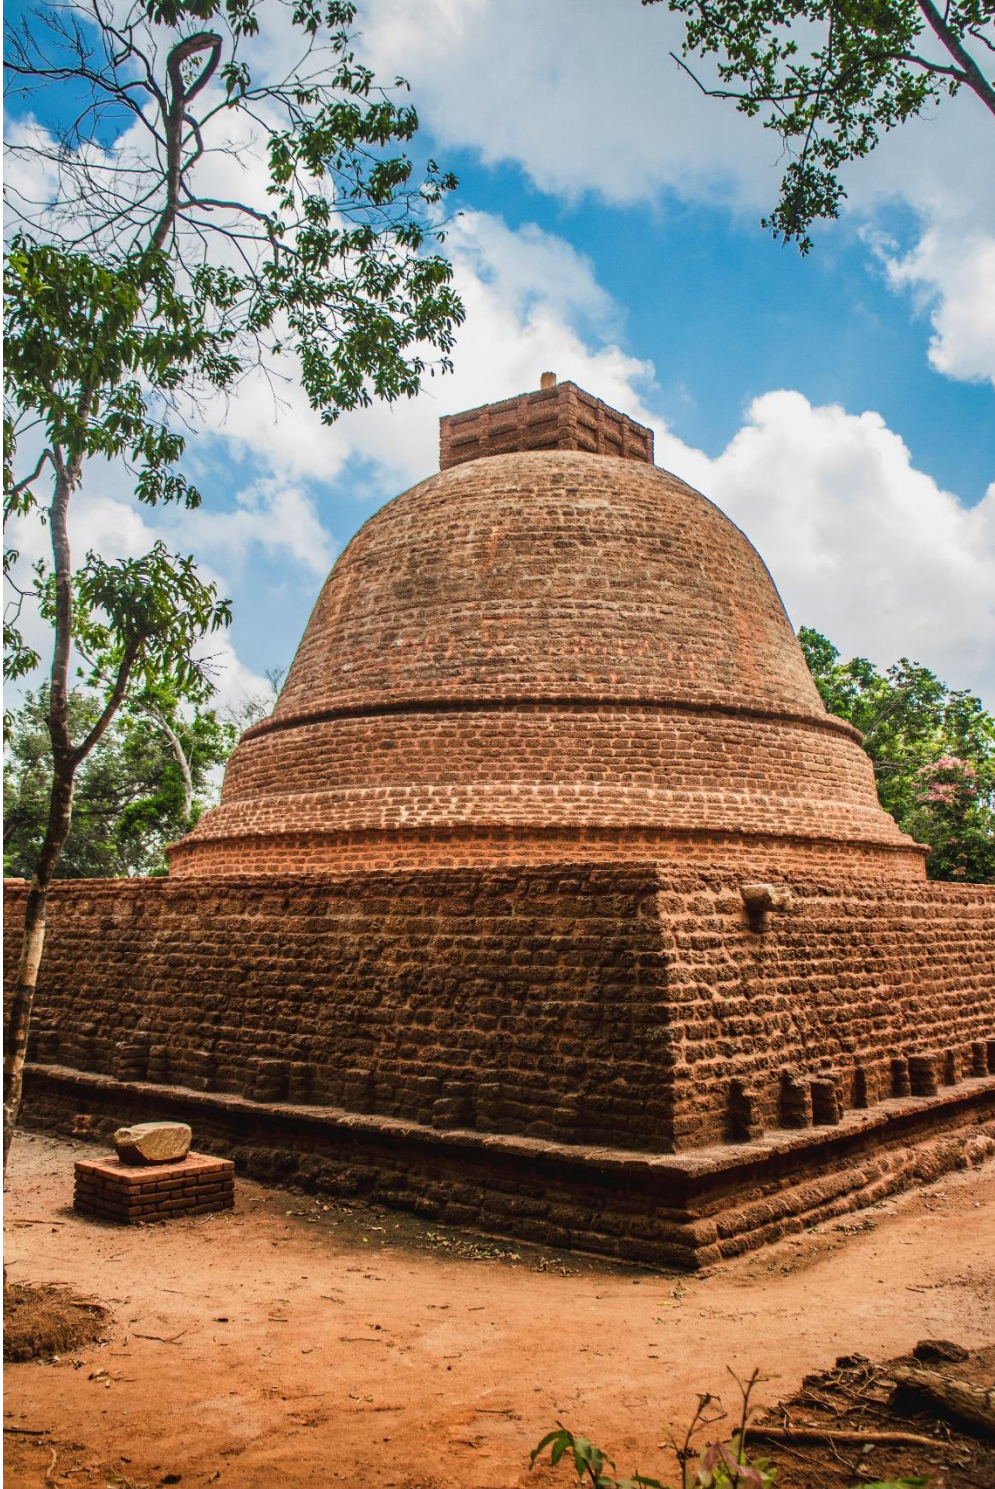
The *stūpa* after conservation

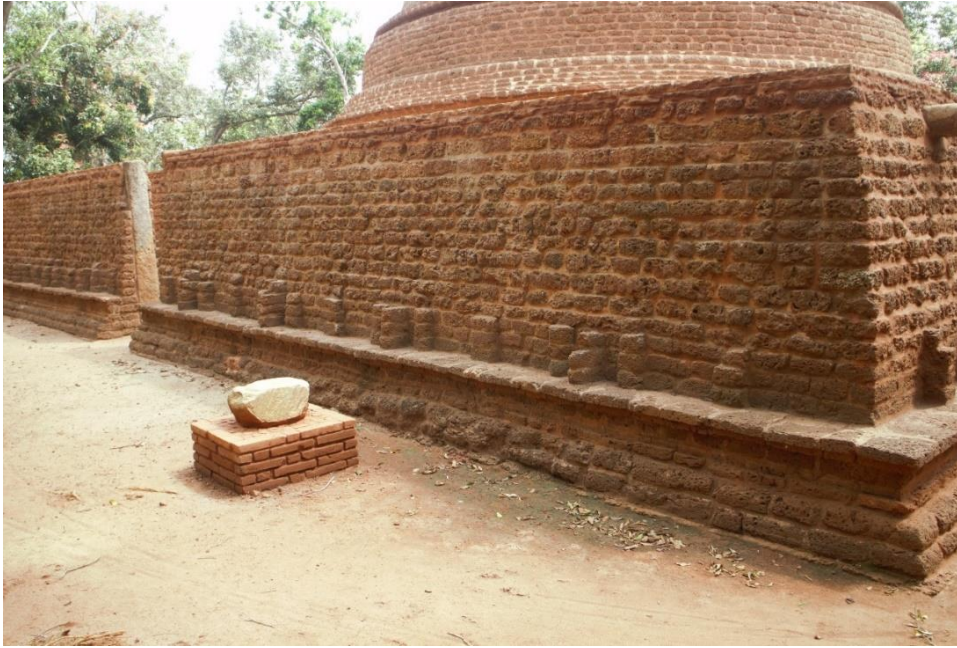
The *stūpa* terrace

A frontal porch to enter the rectangular *stūpa* terrace from the south is found. On entering through the stone porch, two stone flights of steps in two

directions leading to *stūpa* terrace exist. At present, only one pillar remains in the above-mentioned stone porch. According to the details of the construction, it could be conjectured that the porch had a roof over it. This is further confirmed by the fragments of flat tiles found in the vicinity of the porch. It is noteworthy that such a frontal porch built for access to a *stūpa* terrace has not been found anywhere else in the country.

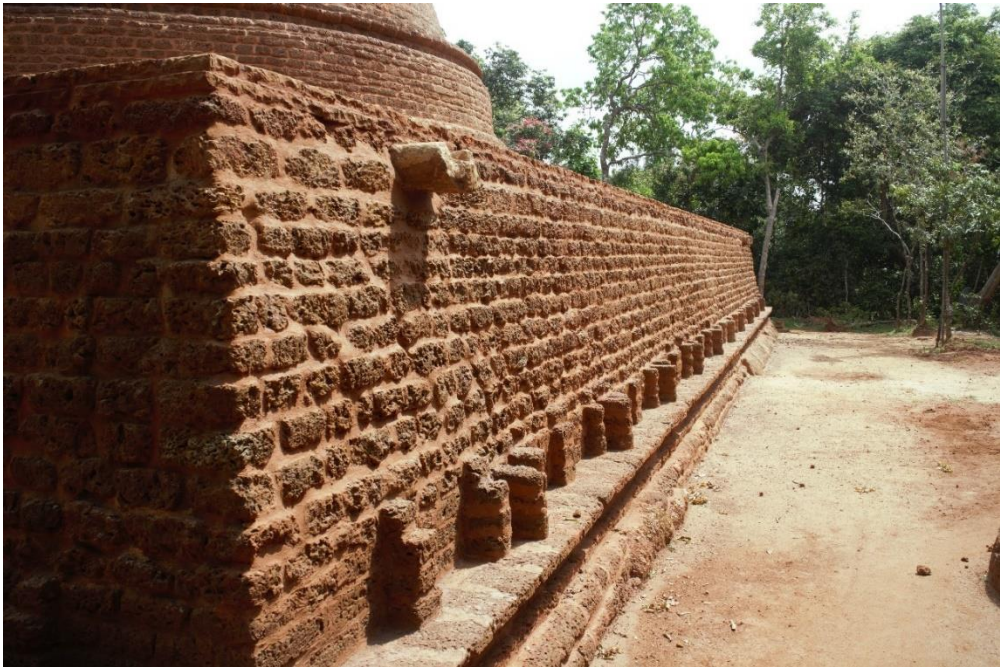
The stūpa platform with fragments of elephant figures

Excavations at the *stūpa* revealed that the treasure hunters have dug up the *stūpa* and looted the antiquities on several occasions. Nevertheless, plaster fragments belonging to the walls of the relic chamber (*dhāthu garbha*) and a fragment of a small gold-plated metal goblet (*mañjusā*) were found (Mullaitivu kurundi vihāra dagāba kanīm vyāpruti vārtāva 2021:38). Among ruins were bricks of different kinds including decorated bricks applied to the building wall surface, fragments of pottery, a *yūpa* stone broken into several pieces, metal coins, flat tiles, a fragment of a blue glass container and a metal bell. A flower altar made of stone and its base, *kabok* stones of various shapes and a variety of stone blocks were also found.

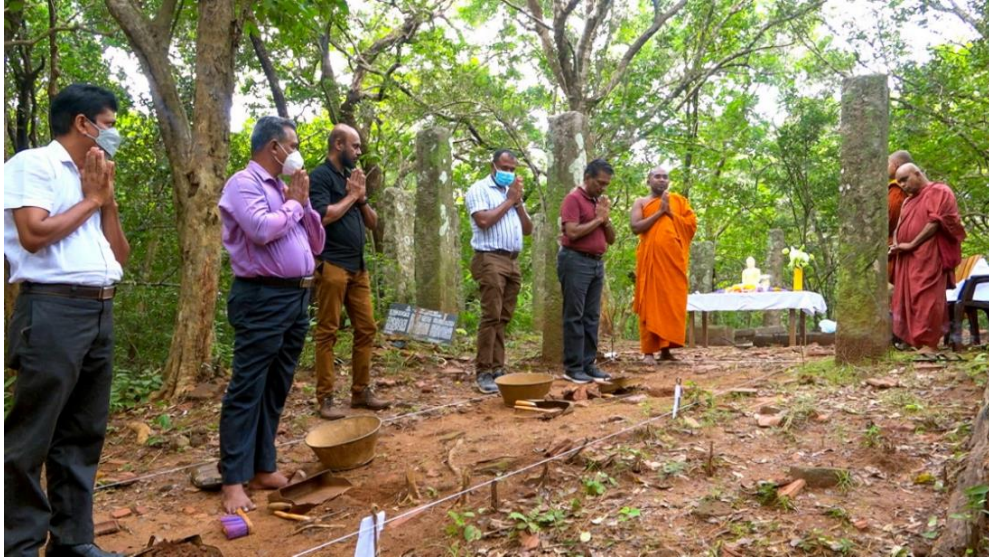
The commencement of excavation of the image house

The building which can be considered as the image house is found at a distance of about 65m from the southwest of the *stūpa*. Bell in his report has also mentioned that the building could be an image house. The image house is built on a 1m high platform having its entrance facing the east. It is 25m in length and 5m in width consisting of a pavilion, a vestibule and an inner chamber each having a pavilion gradually elevated at their entrances. The flight of steps leading to the image house is embellished with stone balustrades and a moonstone. When Bell made his report on this image house, there were no mention of the existence of guard-stones. At the entrance to the image house an unauthorized excavation had damaged the stone balustrades, the moonstone and the flight of steps. Nearly 3m deep pit exists at this spot while the stone balustrades and the moonstone had been damaged. The flight of steps had been unearthed and removed. The Department of Archaeology reports that in 2010 the moonstone had been untouched but the flight of steps had been removed by. The moonstone is decorated only with

Excavations reveal that the rectangular platform, on which the temple complex is built is retained by a *kabok* wall and the inner area of the platform is filled with gravel while structures on the platform were built with baked bricks and stone pillars. The flat tiles seen inside and outside the image house provide evidence that its roof may have been fabricated with the use of stone pillars, timber and flat tiles. In addition, 500 or more blacksmiths iron nails had been found during the excavation conducted by the Department of Archaeology. It could be surmised that these nails may have been used for fabrication of the roof (Mullaitivu Kurundi Vihara Image House excavation report 2022.)

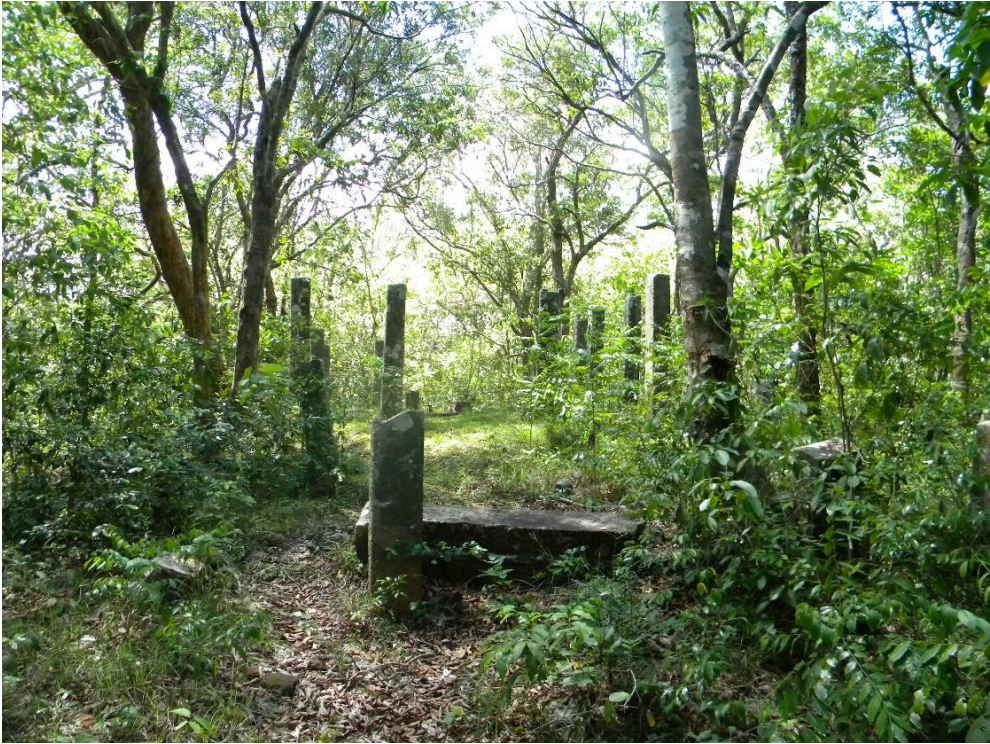
The image house in 2010

had been broken into several pieces and the size of the pit, dug at the place was 1.8m x1.6m x 2.6m. The upper parts of the stone balustrades have been broken. Four steps out of five of the stairway had also been broken. The border of steps is adorned with a magnificent *arimbuva* border motif.

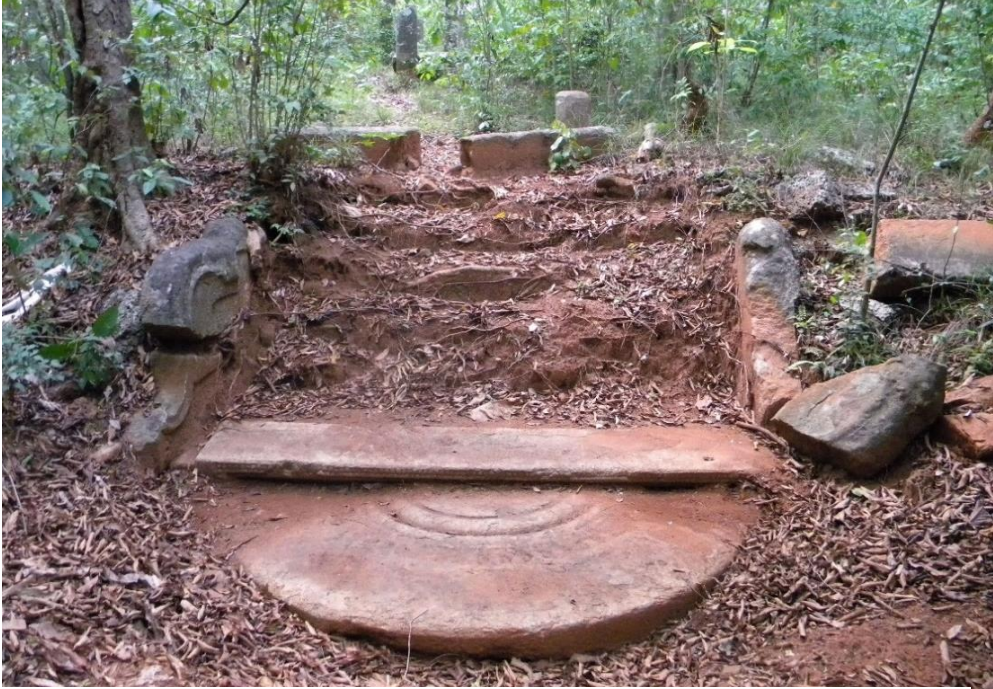
The flight of steps in 2010

By climbing this stairway, the vestibule of the image house could be reached. From the vestibule, the inner chamber could be reached through another flight of steps. The flight of steps, flanked by a pair of balustrades, two identical guard-stones standing in front of the balustrades and an uncarved plain moonstone centrally placed at the foot of the lowest step, provide access to the inner chamber from the vestibule. The upper parts of the two guard-stones had been broken and the lower parts could be seen at ground

level. The pair of balustrades had been broken and the balustrades have the dragon motif and the carved creepers flow out from its mouth. There had been a stone door frame at the entrance to the inner chamber with an exquisitely carved lintel, which

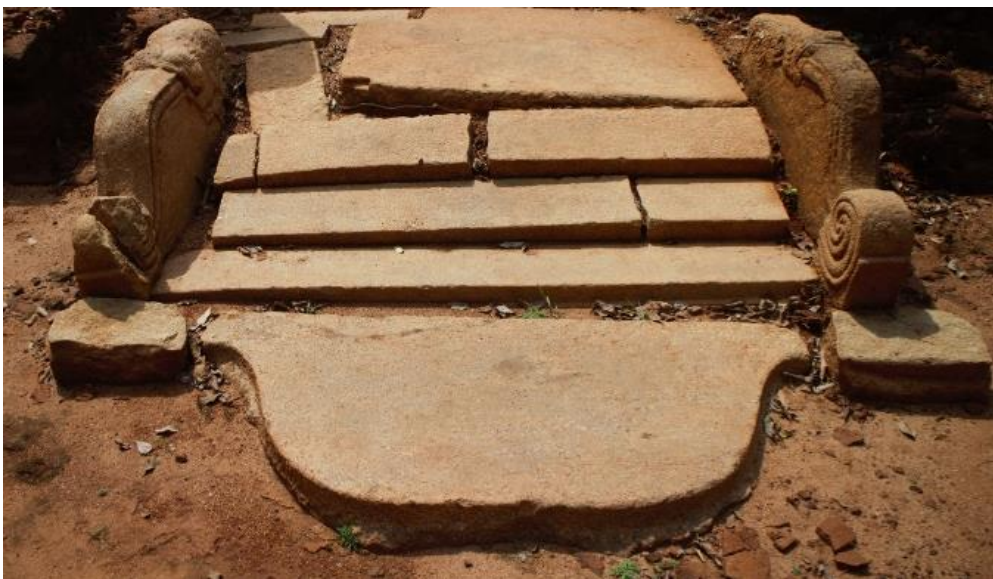
The unerthed flight of steps at the entrance to the image house

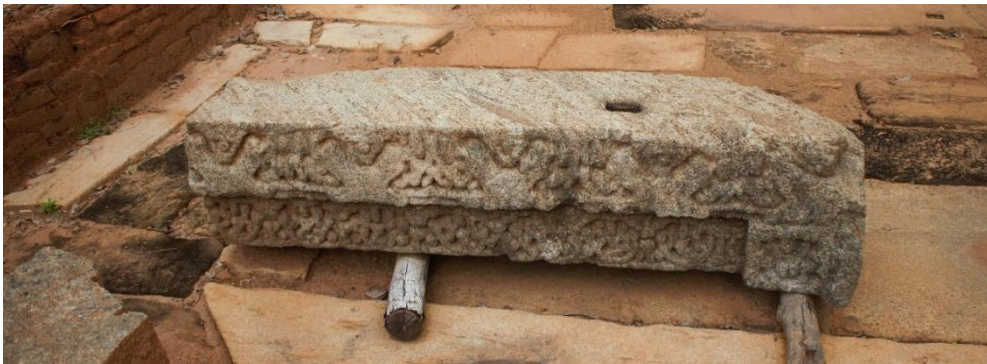
Stone doorframe of the image house

now lies on the floor of the vestibule. It has a rare set of carvings. Bell had mentioned in his report. that there are two rows of carvings. The upper row consists of several sets of male figures and female couples coming out of the mouth of the dragon and a bahirava (gnome) gazing at them. A similar carving is found among the carvings used to decorate the base of outer wall of a mansion in the Vijayārāma monastic complex. The male and the female figures are shown in full relief and their heads are covered with a head dress or a turban. According to Bell, these headdresses appear to be brimless tall hats, where the male and female duo are identified by him as a *bahirava* (gnome) couple.

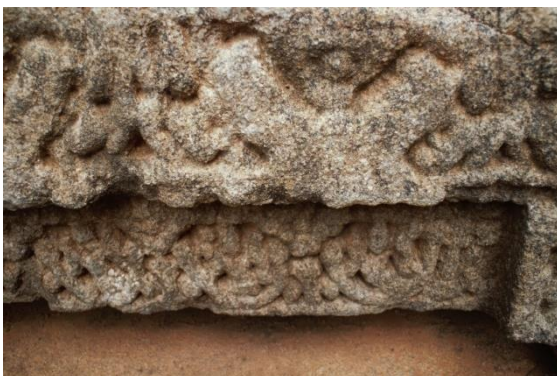
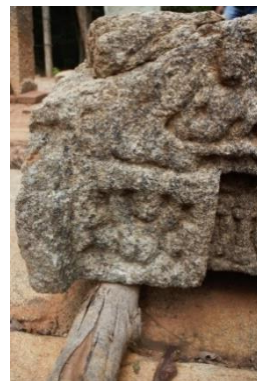
Lintel carvings over the doorframe of the inner chamber of the image house

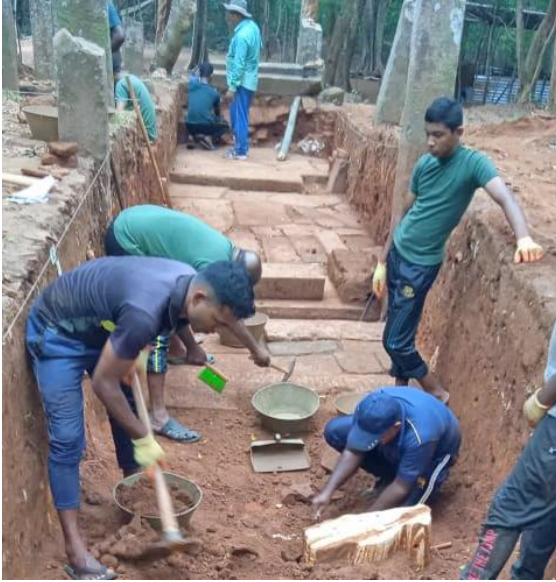
The excavation in progress

The inner chamber is a square like structure measuring 9.8m x 9.6m. To walk within the chamber a circumambulatory path had been laid in its periphery. The Department of Archeology was able to identify that the floor of the chamber had been paved with slabs of assorted sizes, over which mortar had been laid. (Mullaitivu kurundi vihāra piḷimageya kānīm vyāpruti vārtāva 2022).

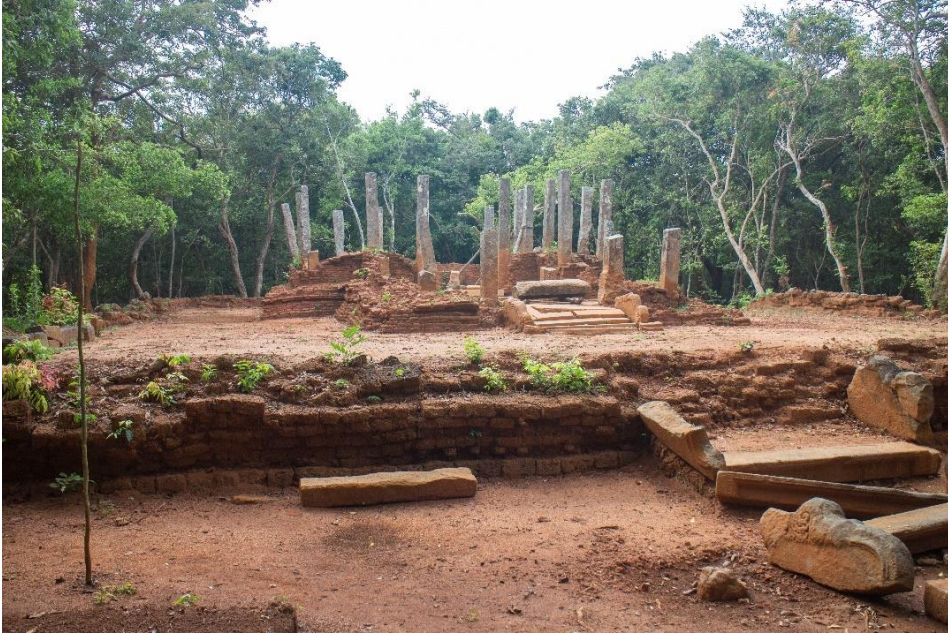
The image house after excavation

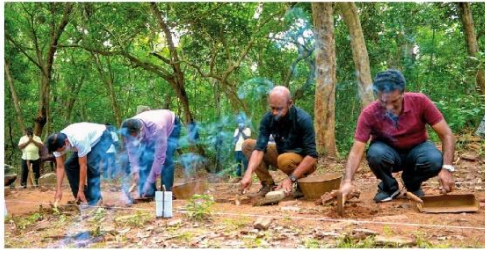
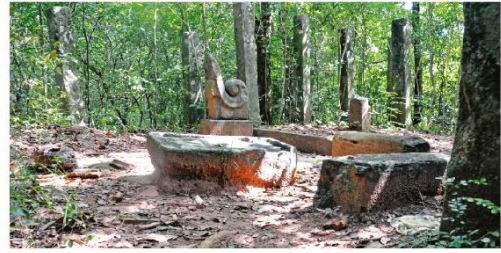
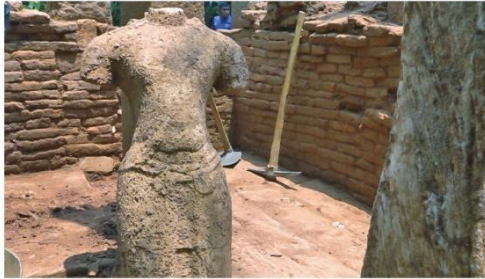
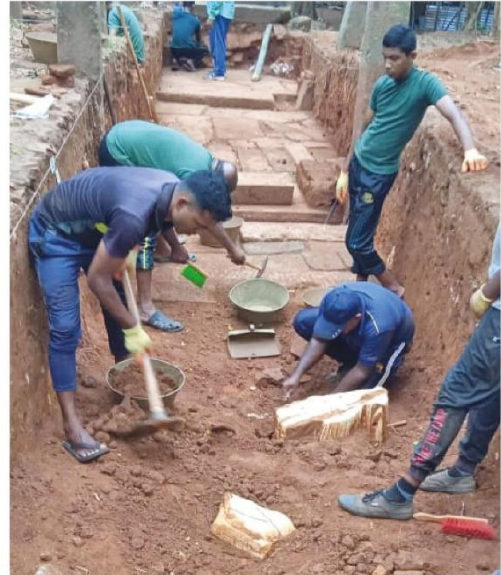
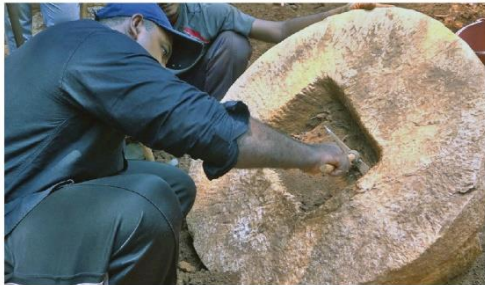
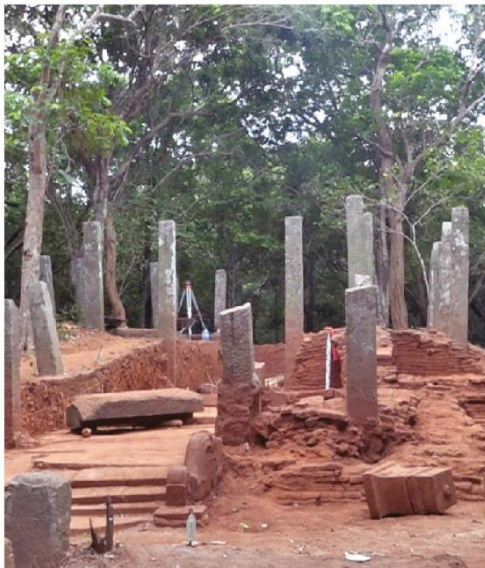
The image house excavation in progress

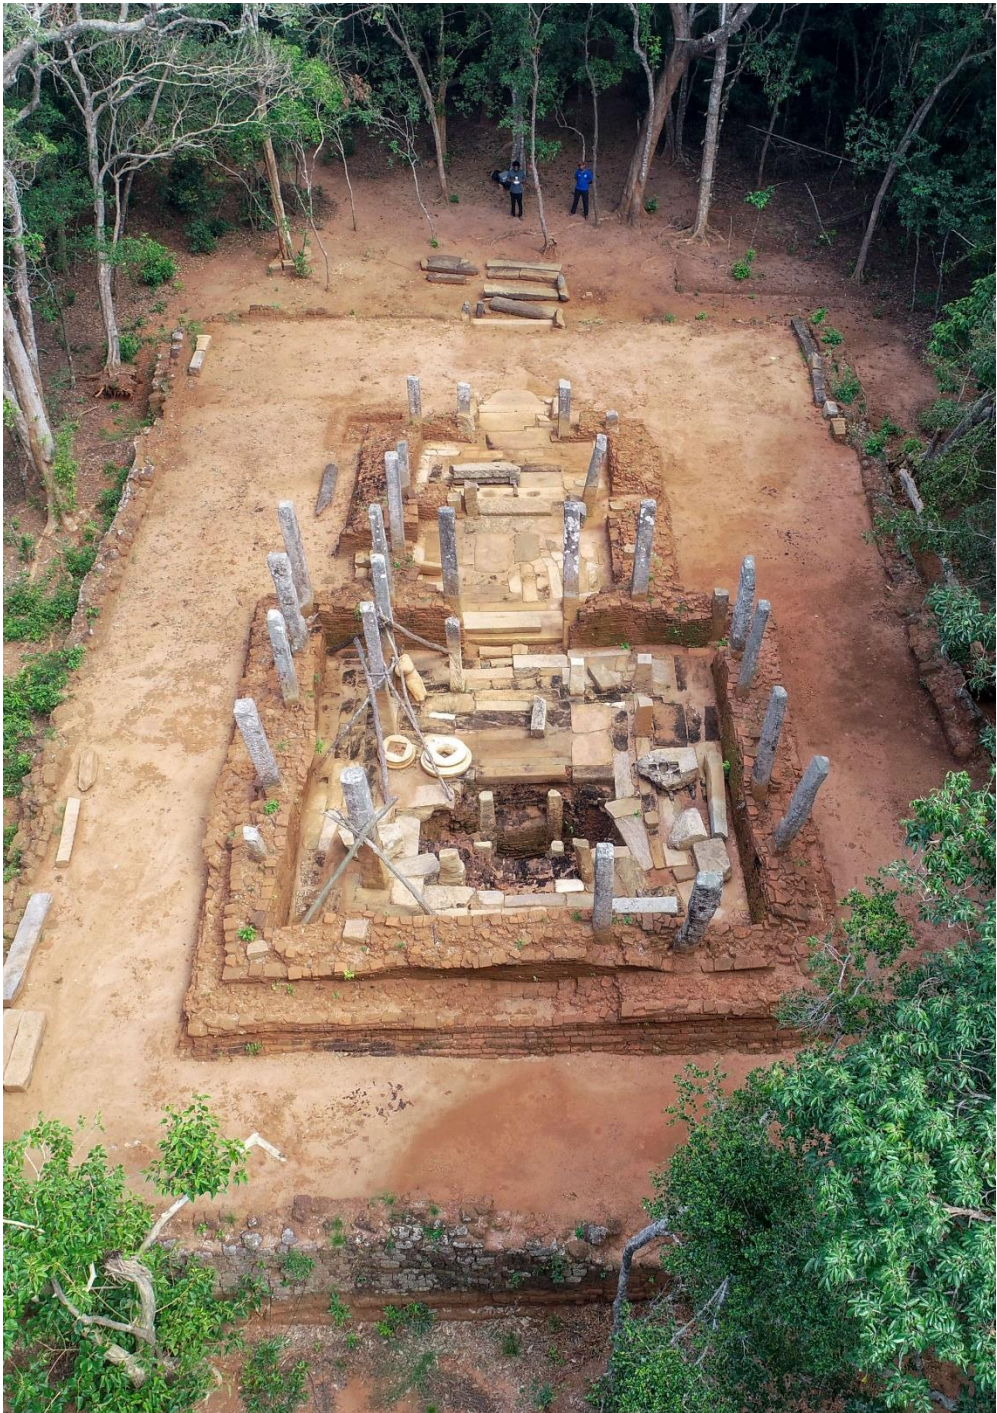
The image house after excavation

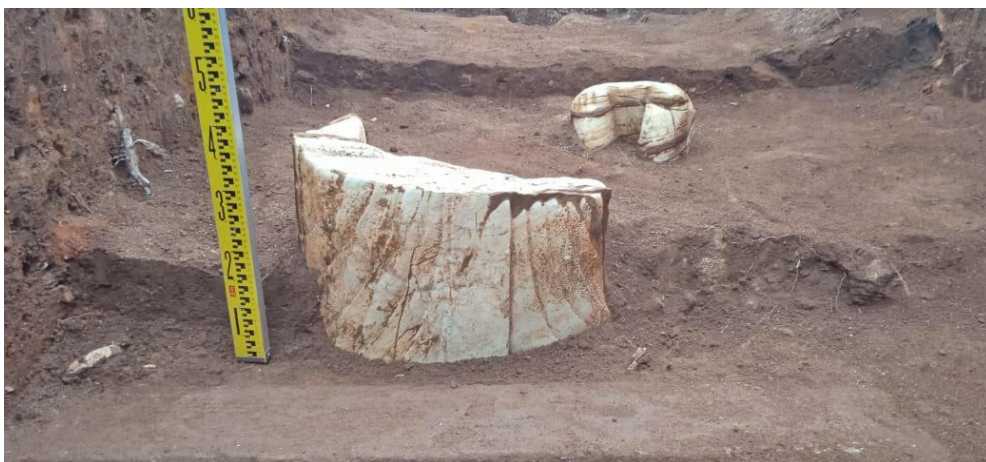
Fragment of Buddha image found during excavation

There is a standing Buddha image made of Andhra hard limestone also known as ‘Andhra marble’. There is a lotus platform made of the same rock material as the base for the image. According to the excavation report, it is conjectured that the rock material may have been brought to Sri Lanka from Andhra Pradesh, India or some other country to sculpt the Buddha image in Sri Lanka (Mullaitivu kurundi vihāra piḷimageya kāmim vyāpruti vārtāva 2022)

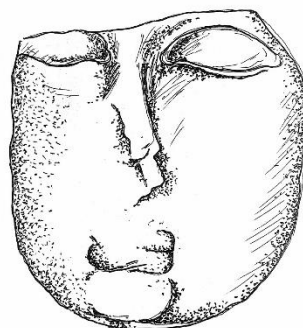
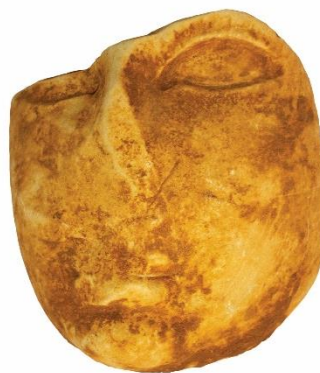
Fragment of Buddha face found during excavation

the feet, and the section of the face of the damaged Buddha image had been discovered during the excavation. The sections of the image provide evidence that there had been a 5ft. tall Buddha statue. (*Mullaitivu kurundi vihāra piḷimageya kānīm vyāpruti vārtāva 2022*). From the appearance of the face of the image, it could be confirmed that its eyes might have been embedded with precious stones. As the main item of the Image House, this image represents the features of the design created in the 3rd- 4th centuries (*Mullaitivu kurundi vihāra piḷimageya kānīm vyāpruti vārtāva 2022*) The base of the image had been decorated with a floral design. There is a hole in the base for positioning the legs of the image and a circular hole behind it, perhaps to retain an umbrella.

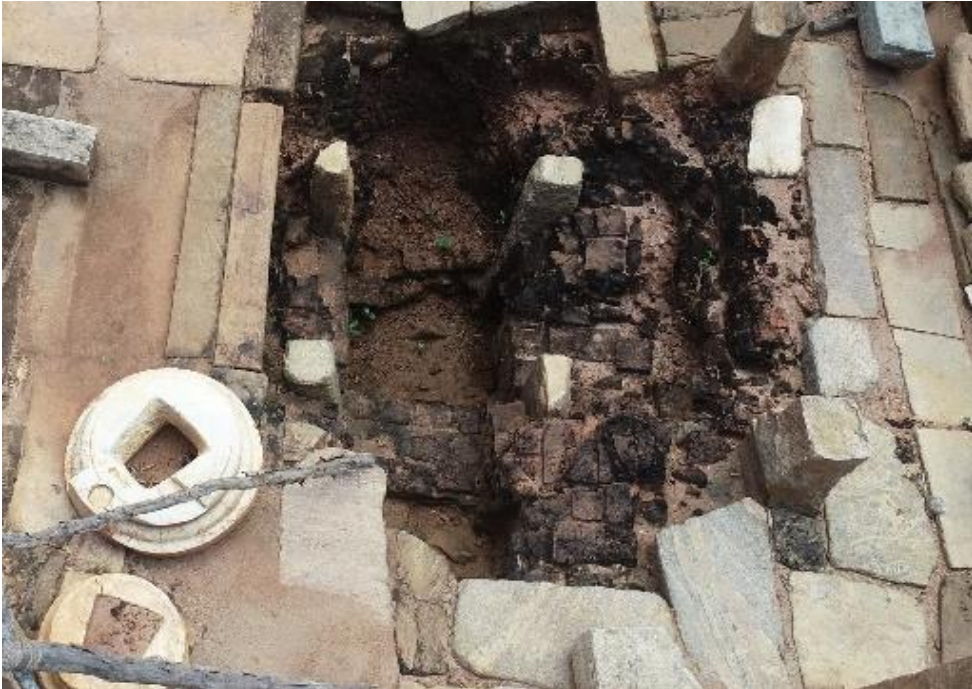
The unauthorized excavation pit at the centre of image house

After the removal of the debris from the pit, which had been arbitrarily dug, it was revealed that this excavation had taken place some time ago. However, this excavation revealed that the bottom of stone slabs of the Image House had been lined with bricks confirming that the Image House had been paved with bricks in the ancient times (Mullaitivu kurundi vihāra piḷimageya kāṇim vyāpruti vārtāva 2022).

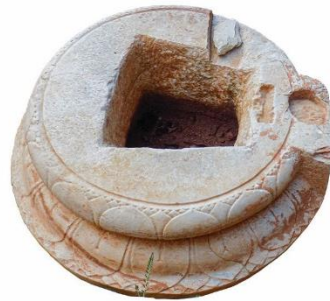
Fragments of the damaged standing Buddha image and recreated Buddha image

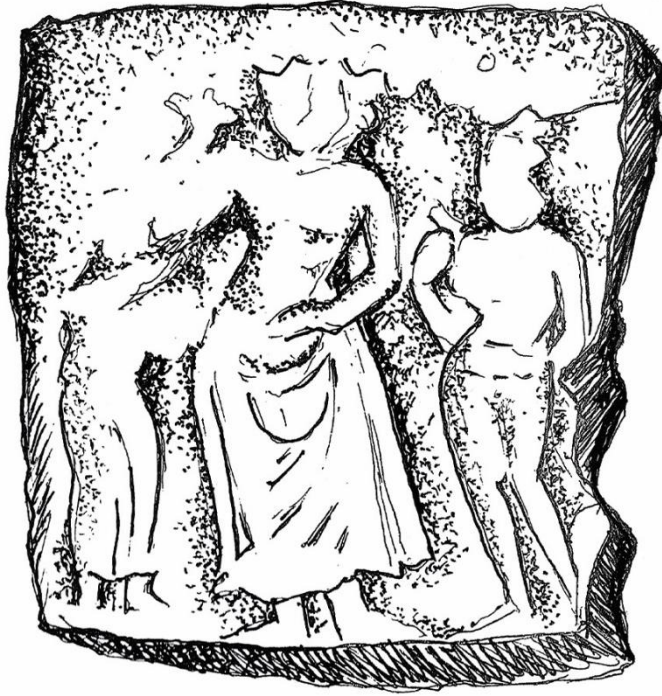
A line drawing of the Avalokiteśvara Bodhisattva plaque

This relief is one of the earliest representations of the Bodhisattva Avalokiteśvara and his consort Tārā. The Bodhisattva Avalokiteśvara, dressed in princely garments, stands frontally and probably holds a lotus flower in his raised right hand. His left hand is held at the waist. The two female figures on either side of Avalokiteśvara are probably two aspects of his consort Tārā, like Shyama Tārā (Green Tara) attended by Sita Tārā (White Tara). One standing to his left, is looking at the Bodhisattva, turning towards him with three-quarter view. She holds a blooming lotus flower in her right hand while the left is held against her left waist. Tārā standing to right hand side of the Bodhisattva also holds a blooming lotus flower in her left hand while her right hand is held against her left waist. Although it is not clear at all, it is possible that there are two flying figures above the Bodhisattva triad (Avalokiteśvara in the middle and two Tārās on either side) throwing flowers in veneration.

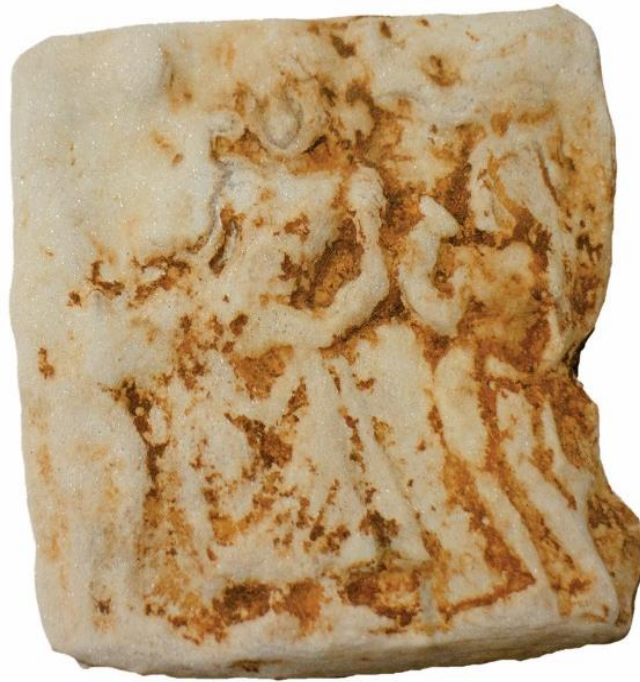
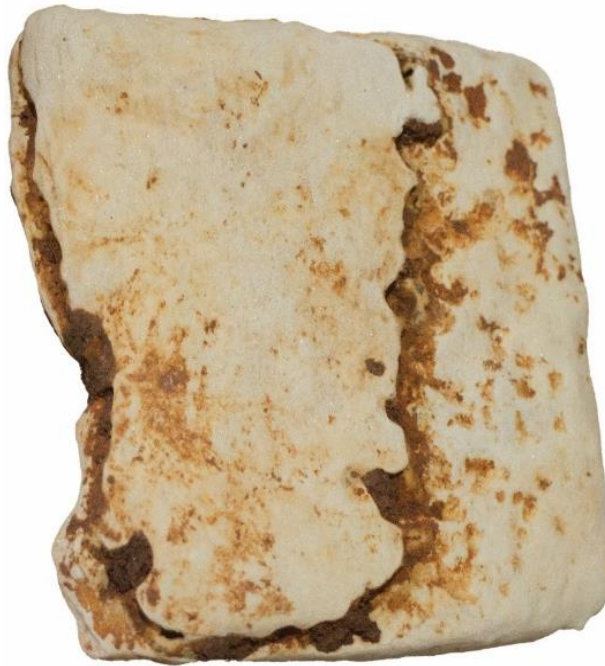
The Avalokiteśvara Bodhisattva plaque

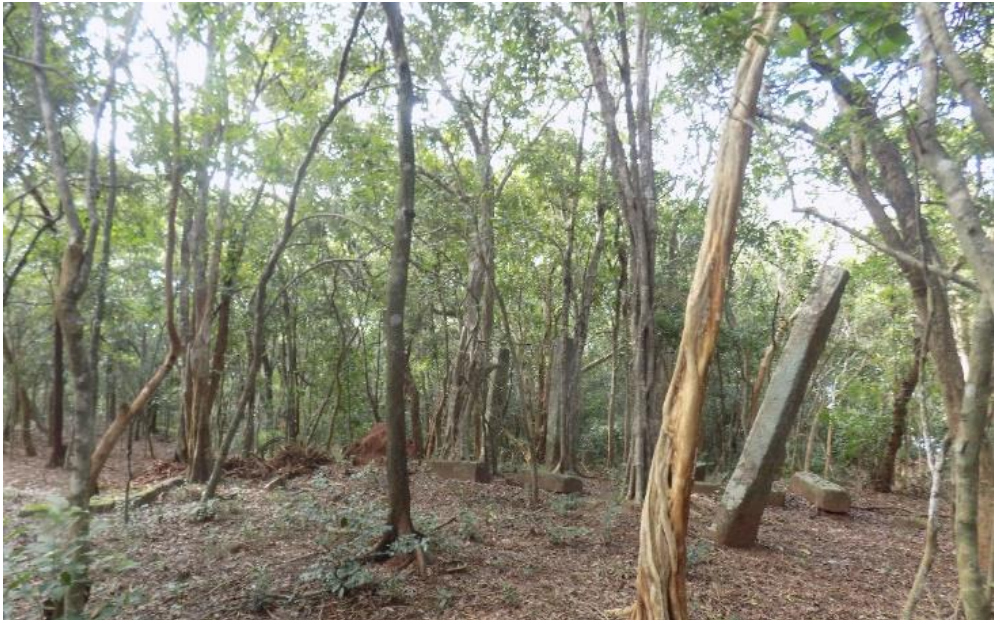
The Chapter House

At a distance of about 45m to the west of the *stūpa* is a relatively large and tall building made of stone columns. Although it is not easy to fathom the use of this building, it could be surmised to be a Chapter House. The building is constructed to cover an area of length 14.30m and width 8.20m with stone pillars arranged in a few rows. The size of stone columns differs to each other marginally. Of the columns erected, seven of them had perished and their remnants are strewn about the place. Of the currently recognized monuments, this construction had used the largest stone pillars of size 33cm x 37cm to a height of 278cm. Bell has reported this building to be the *Vihāra*.

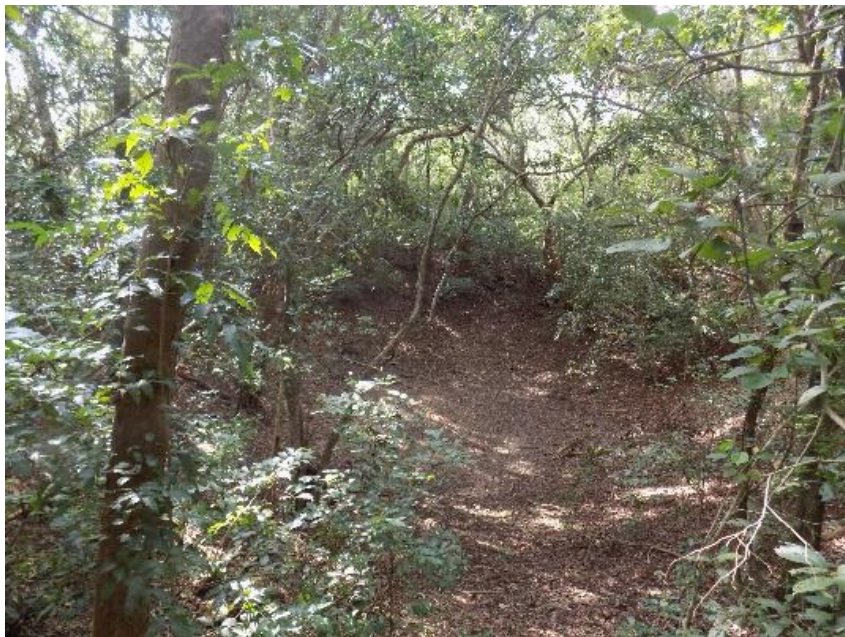
A large pond could be seen at a distance of about 10m outside the western wall behind the image house. The size of the pond is approximately 40m². The depth of the pond is about 10m. This pond may have been used for water

requirements of the upper terrace. The pond had been filled with soil and gradually it had been washed away. This pond can be identified as the largest structure built on the second terrace. In addition, there are remains of buildings including stone pillars. However, the use of these constructions is difficult to discern from the remains. While constructing the wall of the upper terrace, a few stone channels could be seen to have been constructed on the upper terrace to drain the rain water collected on the terrace.

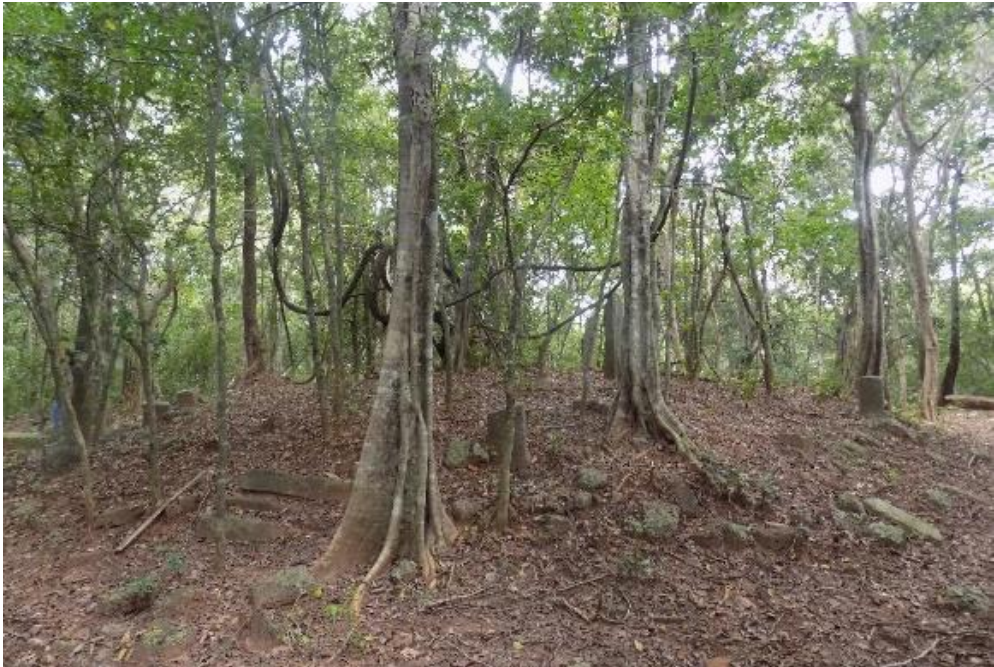
Bodhighara

In addition to the *stūpa*, there are several other ancient monuments on the flat terrace on top of the hill. Ten stone pillars are arranged in a circle at a distance of 65m from the *stūpa* mound. It is presumed that this construction had been a *bōdhighara* (Mullaitivu kurundi vihāra piḷimageya kām̃m vyāpruti vārtāva 2022) Stone pillars had been erected on the circumference of the circle at a fix distance. Few of the pillars are broken and a *kabok* wall

exists around the circular mound which has a diameter of about 10.6m. Some broken pillars bonded with the wall are about 22cm x31cm. The entrance to the mound had been from the north and the three stone steps at the entrance are yet preserved. The size of a step is 40cm X 25cm. The mound visibly high on the plain has three stone pillars in the middle. Bell had identified this construction as a *vaṭadāge*, literally a pillared relic house or a shelter of a *stūpa*.

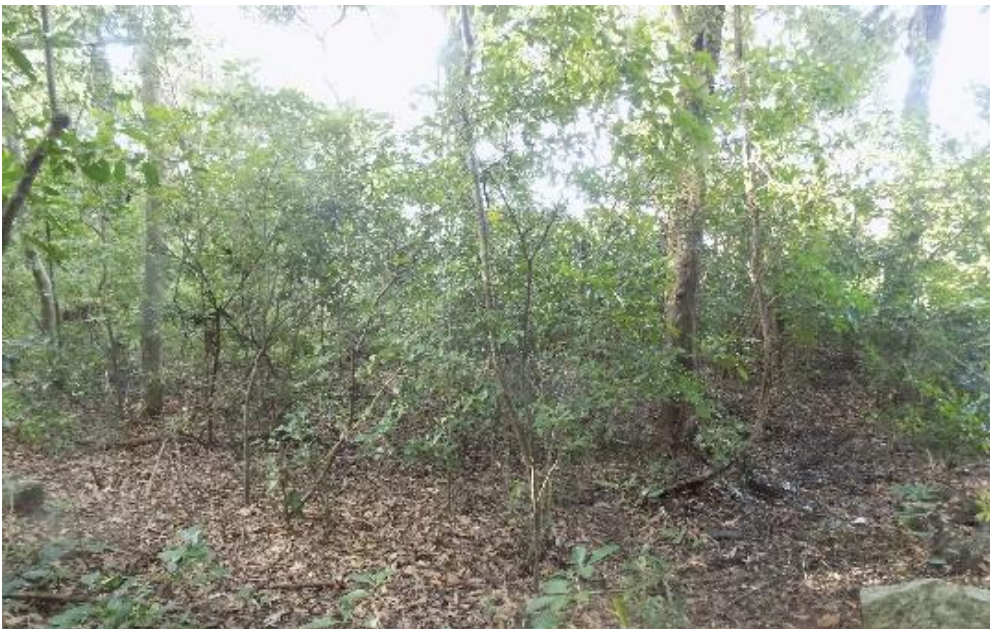
Guardstones located at the foot of the flight of steps in eastern direction

Evidence confirming the access from north and the east to reach the Monastic Complex is visible. A flight of steps exists to reach the summit of the rock along the northern slope. Evidence exists to confirm the flight of steps to have commenced near the bund of the Kurundumalaya tank. a flight of steps is terraced at two points to this approach and at the bottom of the hill a pair of guard stones had been placed to indicate its path. Although the two pairs of guard stones had been covered with debris, their tops are visible with

stones above the debris is 17cm. It is believed that the steps lay buried to a depth of 50cm to 70cm. At a distance of about 15 meters more towards its central part of the slope, the other pair of guard-stones and about 15m further up the slope from here another pair guard-stones are visible. At this point the distance between the two guard-stones is 3.9m. The width of a guard-stone is 45cm. The height of the visible portion of the guard-stone is about 18cm. At a certain spot the steps above the debris confirms the flight of steps remains being buried underground.

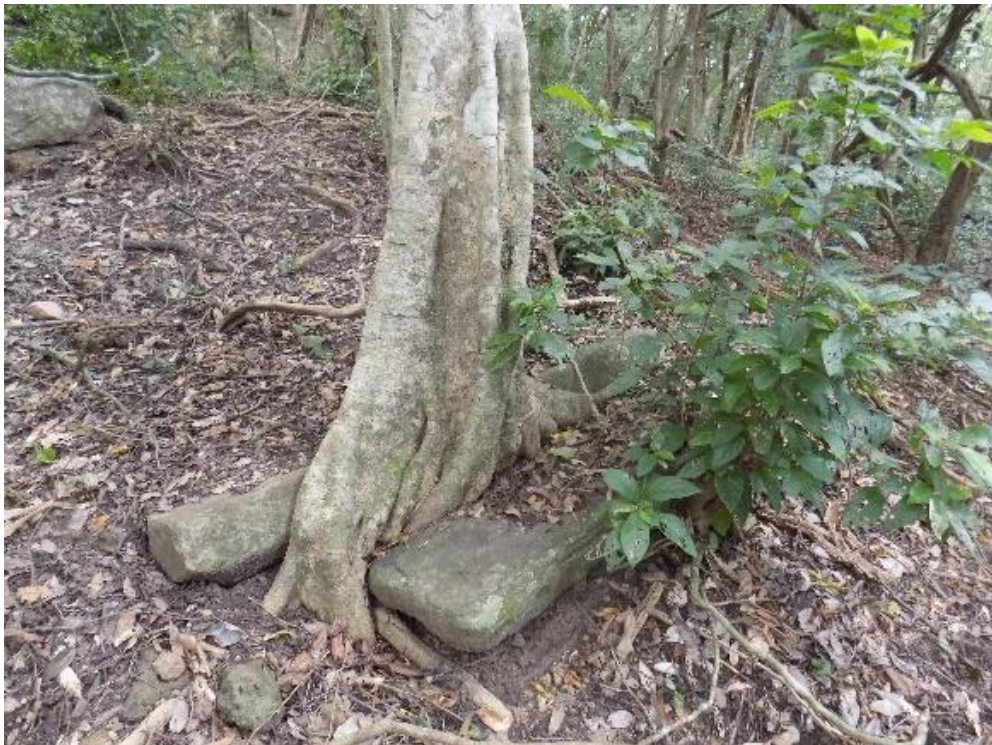
Guardstones located at the foot of the flight of steps in northern direction

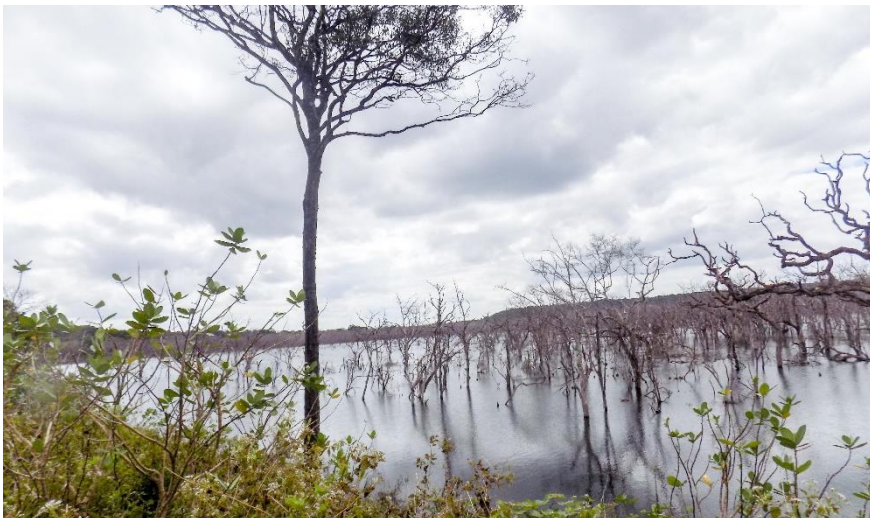
This tank is located to the north of the Kurundi monastic complex. The flight of steps with two guard-stones on either side of it leading to the Temple

Complex on the upper most terrace starts from the tank bund. The tank had been renovated recently. Information regarding the existence of the tank in the past is not available. The tank bund extending in the north-south direction has at its centre portion several ancient stone pillars brought from or toppled from the frontal area of the tank embankment.

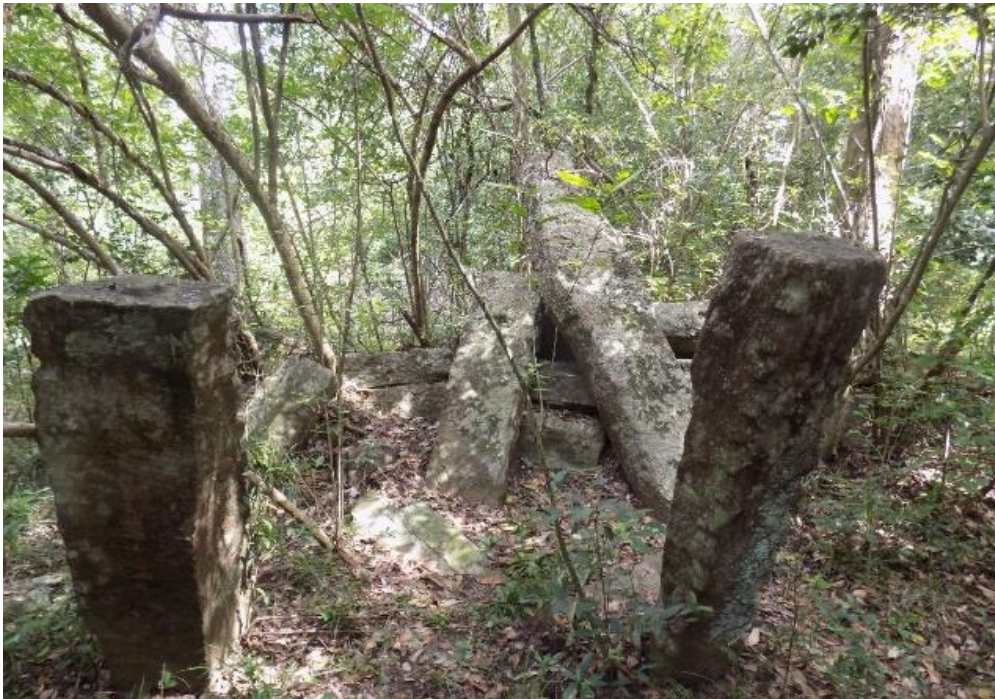
construction clearly identifiable is a stone bridge over a stream at the end of the embankment of the tank, built in the east-west direction of eight pillars in rows of two. There is a large number of overturned stone pillars and stone slabs at the site. Three toppled stone pillars are seen near the waterway in close proximity to the stone bridge. At one end of the bridge, a mound that

could be conjectured as a building exists.
